FACILITY NEEDS ASSESSMENTS

EISENHOWER ELEMENTARY SCHOOL

2020 | FACILITIES MASTER PLAN

FACILITY CONDITION ASSESSMENT

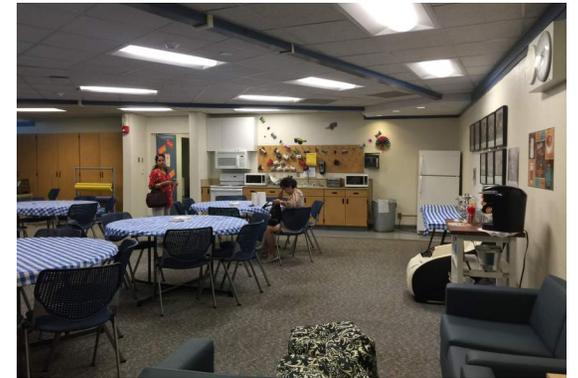
Faculty Lounge

The STAR building and GLC were not included in the modernization. The STAR building houses the Faculty Lounge, ALC and the food service area. Temporary partition, walls separate the food servery area from the professional development space and storage.
