FACILITY NEEDS ASSESSMENTS

LINCOLN ELEMENTARY SCHOOL

2020 | FACILITIES MASTER PLAN

FACILITY CONDITION ASSESSMENT

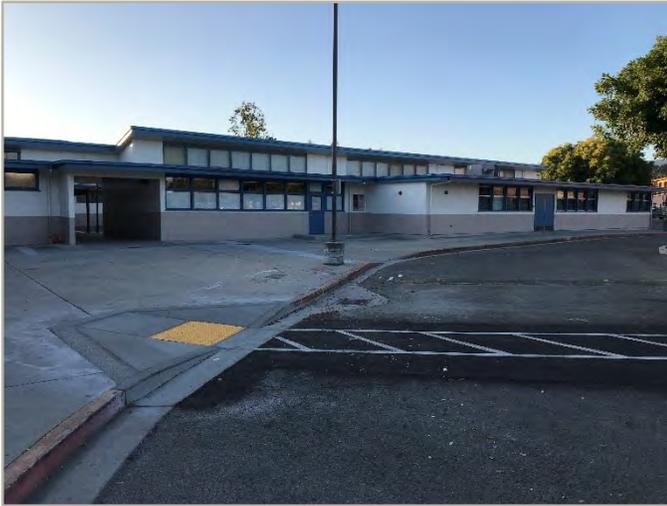
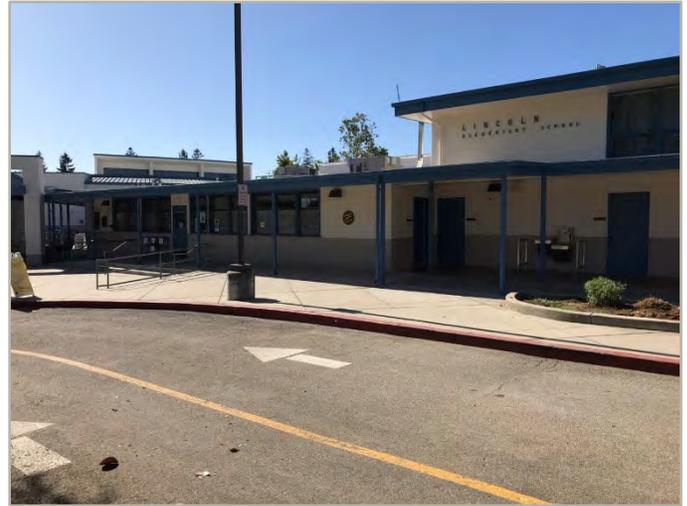
2. Administration Building

Constructed/Renovated	1950	
Building Size	10,711 SF	
Number of Stories	1	
<i>System</i>	<i>Description</i>	<i>Condition</i>
Structure	Masonry and wood frame structure on concrete slab	Good
Façade	EIFS with aluminum windows	Good
Roof	Flat construction with single-ply TPO/PVC membrane	Poor
Interiors – 940 only	Walls: Painted gypsum board and acoustic tile Floors: Carpet, VCT, ceramic tile Ceilings: Painted gypsum board, ACT, exposed	Good
Elevators	None	--
Plumbing	Copper supply and cast iron waste and venting. Electric domestic water heaters. Toilets and sinks in all restrooms	Good
HVAC	940 area package unit 900 offices have three package units	Good

Administration Building 900/940: Systems Summary		
Fire Suppression	Fire extinguishers	Good
Electrical	Source and Distribution: Building panels with copper wiring. Fed from exterior service entrance section at transformer. Interior Lighting: T-12, LED, CFL	Good
Fire Alarm	Fire Alarm panel, smoke detectors, alarms, strobes, pull stations, back-up emergency lights, and exit signs. Fire alarm systems were upgraded 2016	Good
Equipment/Special	Assembly (940) and stage with fold-out bleachers Former cafeteria used as storage and maintenance office	--
Accessibility	No significant issues observed.	
Key Issues and Findings	Roof membranes at the 900 and 940 sections are at or beyond their useful service life and should be replaced. The glued-on ceiling tiles, lighting and older 9x9 vinyl floor tile in the 940 section are at or beyond their useful service life and should be replaced.

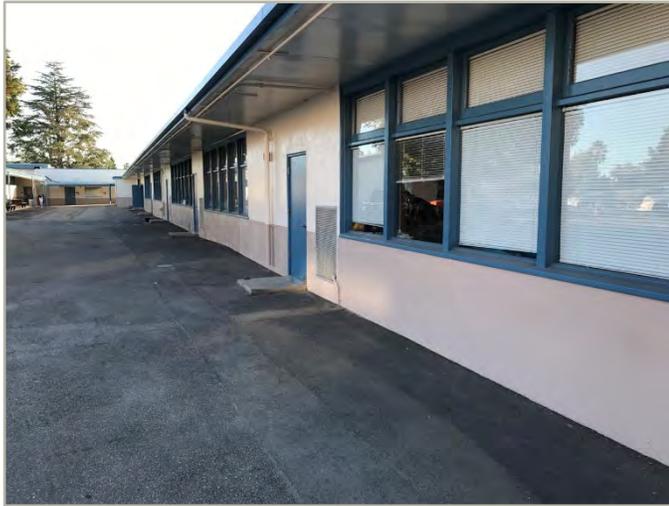
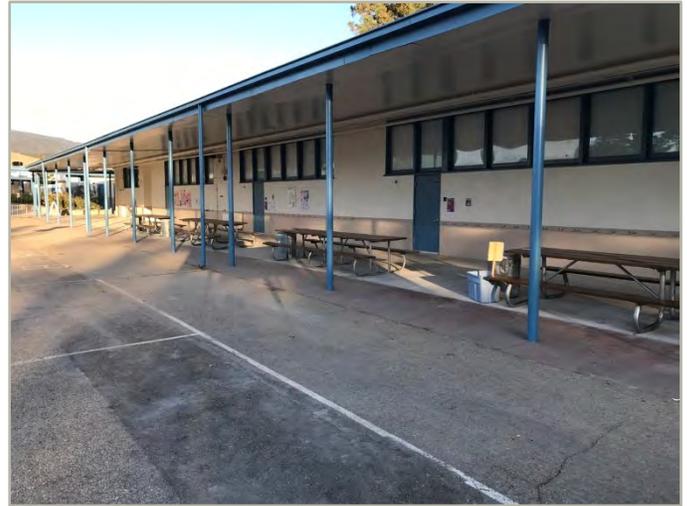
3. Classrooms

Constructed/Renovated	1950s	
Building Size	16,150 SF	
Number of Stories	1	
<i>System</i>	<i>Description</i>	<i>Condition</i>
Structure	Masonry and wood frame structure on concrete slab	Good
Façade	EIFS with aluminum windows	Good
Roof	Primary: Flat construction with built-up finish Secondary: Single ply membrane with coating	Fair
Interiors	Walls: Painted gypsum board and vinyl wall covering Floors: Carpet, VCT, ceramic tile Ceilings: Painted gypsum board, ACT, exposed	Good
Elevators	None	--
Plumbing	Copper supply and cast iron waste and venting. Electric domestic water heaters. Toilets and sinks in exterior restrooms	Good
HVAC	Individual wall mounted heat pump units; 3 split system heat pumps Two packaged roof top units	Good
Fire Suppression	Fire extinguishers	Good

Electrical	Source and Distribution: Building panels with copper wiring. Fed from exterior service entrance section at transformer. Interior Lighting: T-12, LED, CFL	Good
Fire Alarm	Fire Alarm panel, smoke detectors, alarms, strobes, pull stations, back-up emergency lights, and exit signs. Fire alarm systems were upgraded 2016.	Good
Equipment/Special	None	--
Accessibility	No significant issues observed.	
Key Issues and Findings	No significant issues were identified.

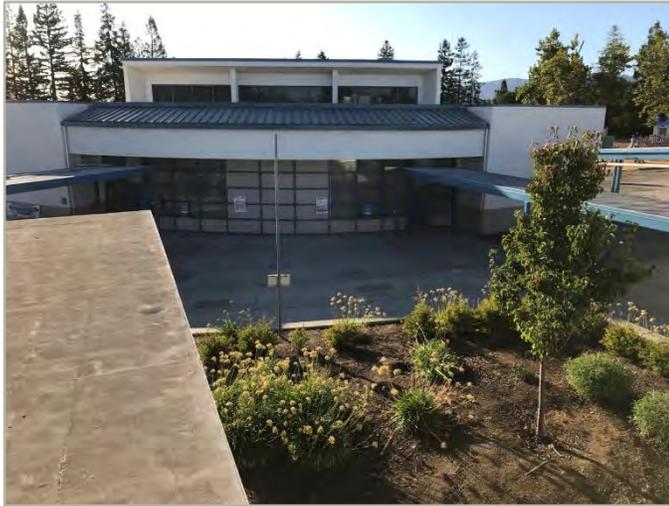
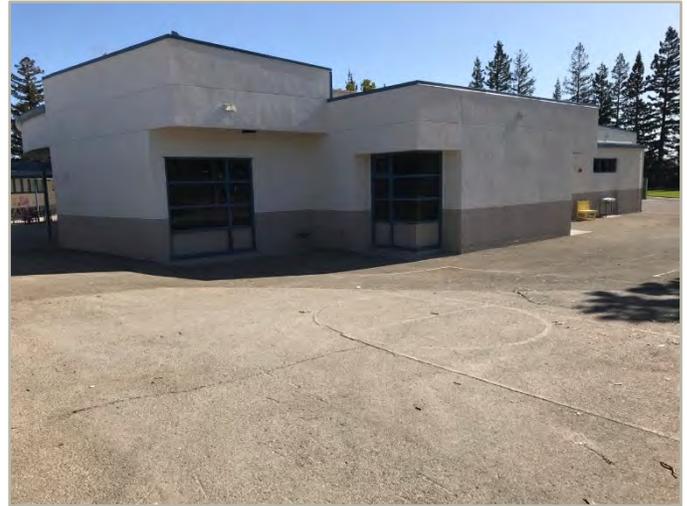
4. Guided Learning Center

Constructed/Renovated	1995/1997	
Building Size	12,000 SF	
Number of Stories	1	
<i>System</i>	<i>Description</i>	<i>Condition</i>
Structure	Masonry and wood frame structure on concrete slab	Good
Façade	EIFS with aluminum windows	Fair
Roof	Primary: Flat construction with rubber membrane with stone ballast Secondary; Pitched section with standing seam metal panels	Good
Interiors	Walls: Painted gypsum board and vinyl wall covering Floors: Carpet, VCT, ceramic tile, quarry tile Ceilings: Painted gypsum board, ACT, exposed	Good
Elevators	None	--
Plumbing	Copper supply and cast iron waste and venting. Electric domestic water heaters. Toilets, urinals, and sinks in all restrooms	Good
HVAC	Package gas-fired units.	Good
Fire Suppression	Fire extinguishers	Good

Electrical	Source and Distribution: Main service entrance section at transformer. Building panels with copper wiring. Fed from exterior service entrance section at transformer. Interior Lighting: T-12, LED, CFL	Good
Fire Alarm	Smoke detectors, alarms, strobes, pull stations, back-up emergency lights, and exit signs. Fire alarm systems were upgraded 2016	Good
Equipment/Special	None	--
Accessibility	No significant issues observed.	
Key Issues and Findings	Painting, some interior finish and HVAC units will require replacement.

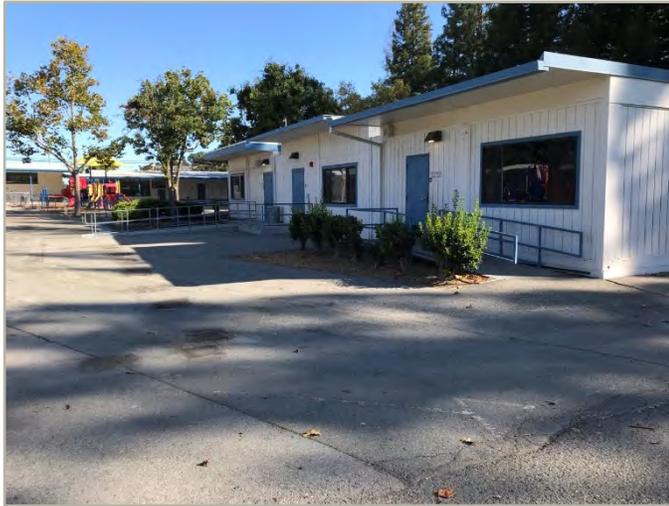
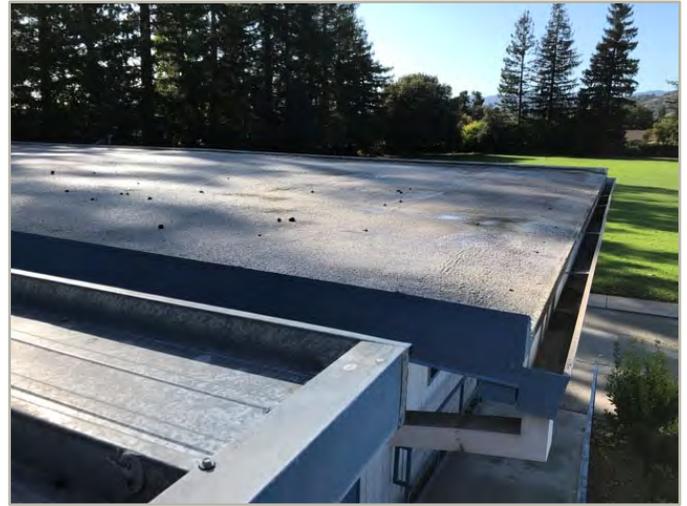
5. Modular Classrooms

Constructed/Renovated	Placed in service 1996 to 2008	
Building Size	14,000 SF	
Number of Stories	1	
<i>System</i>	<i>Description</i>	<i>Condition</i>
Structure	Conventional wood frame structure on with raised floor set on concrete piers or blocks. Modular.	Good
Façade	Wood siding with aluminum windows	Good
Roof	Primary: Flat construction with built-up finish	Good
Interiors	Walls: Painted gypsum board Floors: Carpet, VCT, Ceilings: Suspended acoustical tile	Good
Elevators	None	--
Plumbing	Copper supply and cast iron waste and venting. Tankless water heaters. Toilets and lavatories in exterior restrooms.	Good
HVAC	Individual wall mounted heat pump units	Good
Fire Suppression	No fire sprinklers	--

Electrical	Source and Distribution: Exterior building panels with copper wiring. Fed from exterior service entrance section at transformer. Interior Lighting: T-12, CFL	Good
Fire Alarm	Smoke detectors, alarms, strobes, pull stations, back-up emergency lights, and exit signs. Fire alarm systems were upgraded 2016	Good
Equipment/Special	None	--
Accessibility	No significant issues observed.	
Key Issues and Findings	No significant issues were identified.

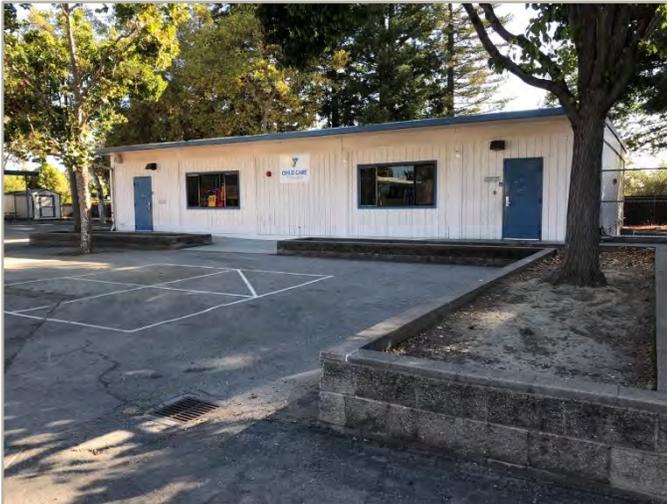
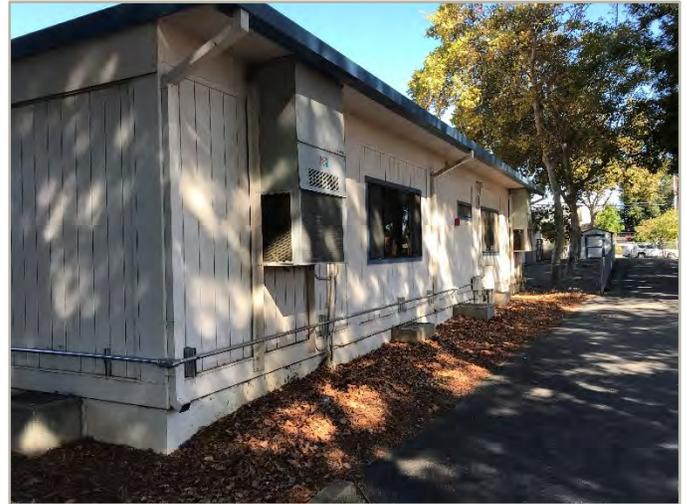
6. Student Care Center

Constructed/Renovated	1996	
Building Size	2,000 SF	
Number of Stories	1	
<i>System</i>	<i>Description</i>	<i>Condition</i>
Structure	Conventional wood frame structure on with raised floor set on concrete piers or blocks. Modular.	Good
Façade	Wood siding with aluminum windows	Good
Roof	Primary: Flat construction with metal finish	Good
Interiors	Walls: Painted gypsum board, vinyl Floors: Carpet, VCT, Ceilings: Painted gypsum board	Good
Elevators	None	--
Plumbing	Copper supply and cast iron waste and venting. Tankless water heaters. Two interior restrooms	Good
HVAC	Individual wall mounted heat pump units	Good
Fire Suppression	No fire sprinklers	--

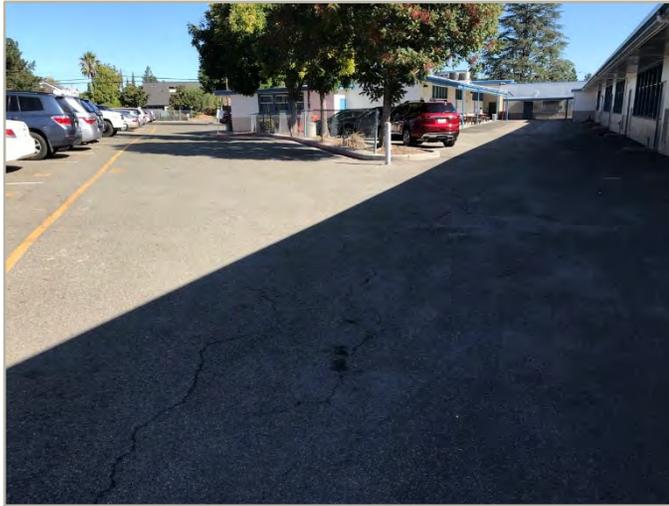
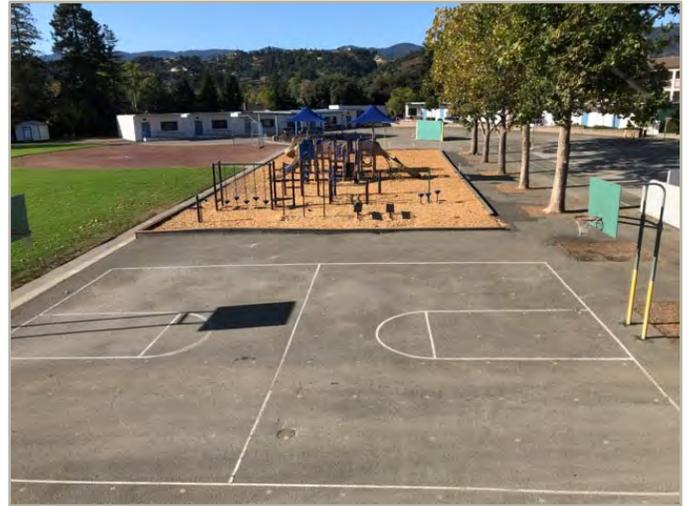
7. Site Summary

Lot Size	10 acres (estimated)	
Parking Spaces	60 total spaces all in open lots; 4 of which are accessible	
<i>System</i>	<i>Description</i>	<i>Condition</i>
Pavement/Flatwork	Asphalt lots with areas of concrete and concrete sidewalks, curbs, ramps, and stairs	Good
Site Development	Property entrance signage, chain link fencing, chain link dumpster enclosures Playgrounds and sports courts with bleachers, fencing, and site lights Heavily furnished park benches, picnic tables, trash receptacles. Playground equipment.	Good
Landscaping and Topography	Moderate landscaping features. Irrigation present Low to moderate site slopes throughout property	Good
Utilities	Municipal water and sewer Local utility-provided electric and natural gas	Good
Site Lighting	Building-mounted LED Pedestrian walkway lighting surface mounted in canopies	Good
Ancillary Structures	Metal framed canopy/sunshade structures	Good
Accessibility	See Section 9.

Key Issues and Findings	No significant deficiencies observed. Comprehensive replacement of site components as they reach the end of their useful service life
