REGNART ELEMENTARY SCHOOL

2020 | FACILITIES MASTER PLAN

FACILITY CONDITION ASSESSMENT

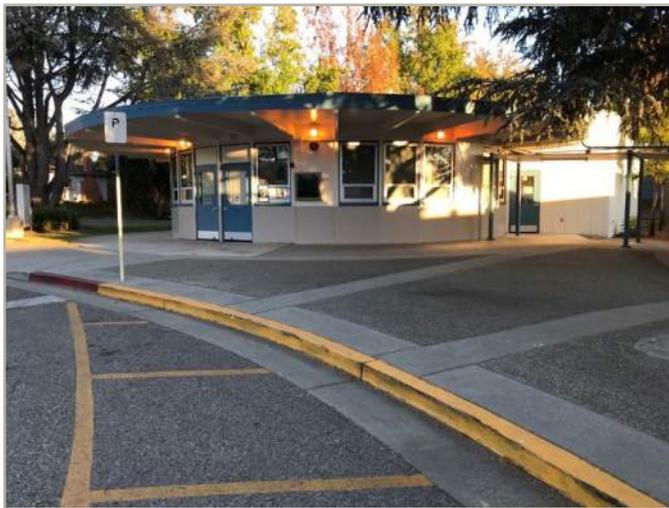
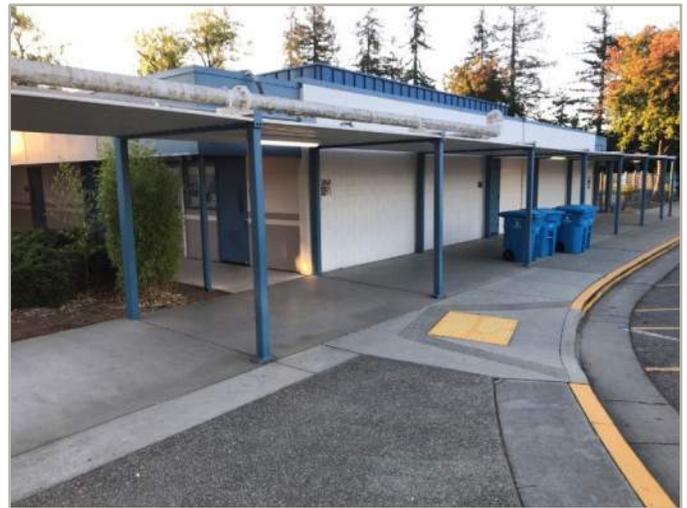
Permanent Buildings: Systems Summary

Equipment/Special	None	--
Accessibility	Presently it does not appear an accessibility study is needed for this property.	
Key Issues and Findings	Painting of the underside of the exterior metal canopy is required.

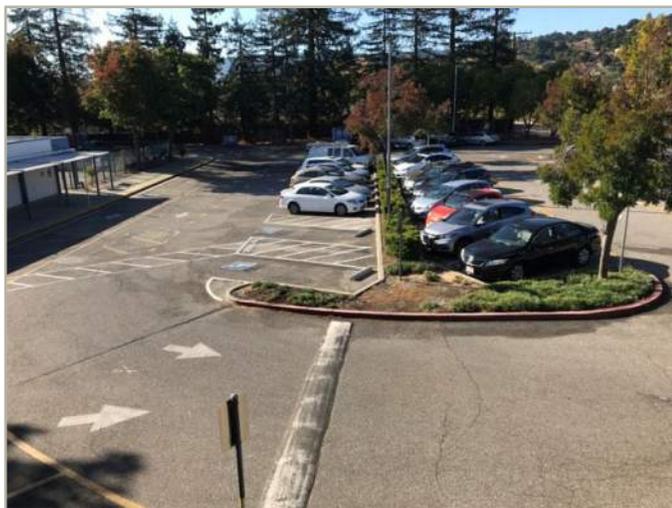
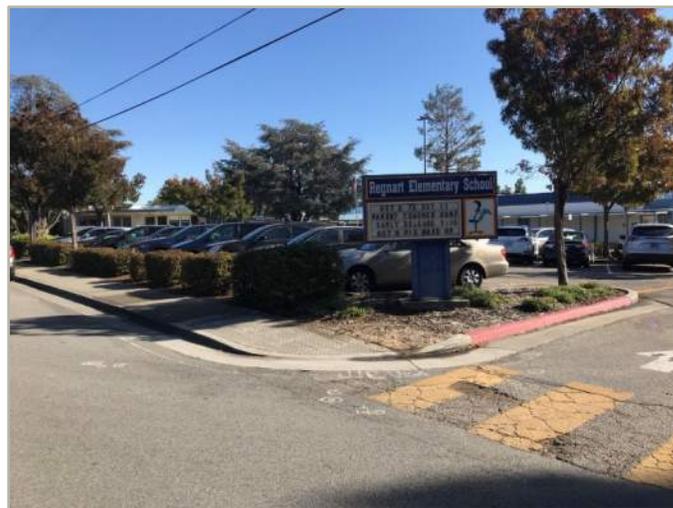
Key Issues and Findings	No significant deficiencies observed. Comprehensive replacement of site components as they reach the end of their useful service life
