SEDGWICK ELEMENTARY SCHOOL

2020 | FACILITIES MASTER PLAN

FACILITY CONDITION ASSESSMENT

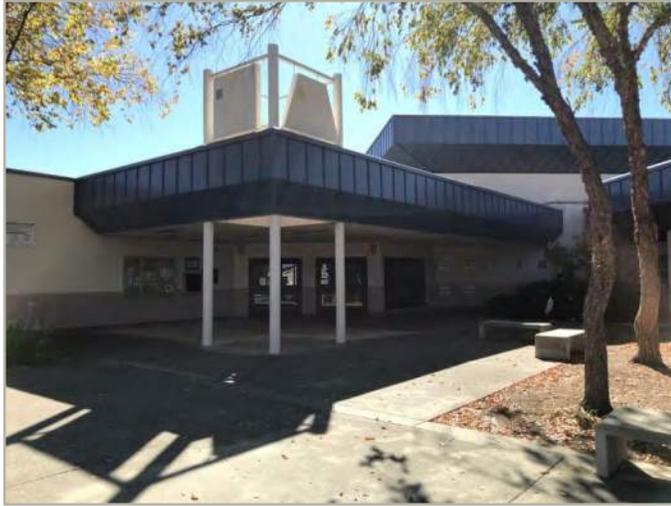
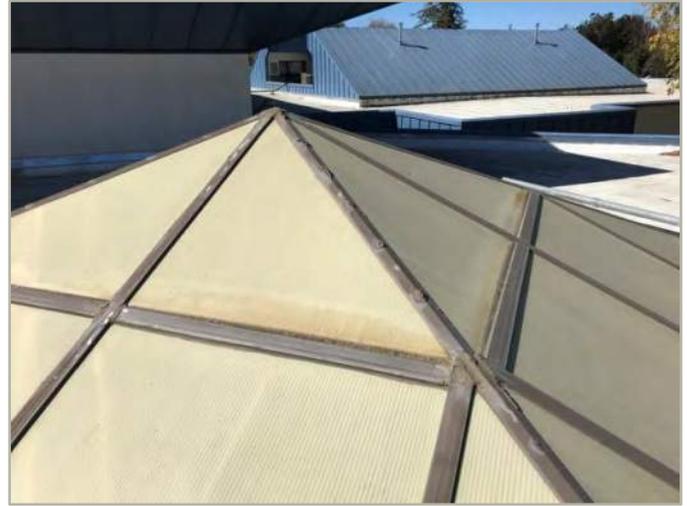
2. Administration 900

Electrical	Source and Distribution: Building panels with copper wiring. Fed from exterior service entrance section at transformer. Interior Lighting: T-12, LED, CFL	Good
Fire Alarm	Fire Alarm panel, smoke detectors, alarms, strobes, pull stations, back-up emergency lights, and exit signs	Good
Equipment/Special	None	--
Accessibility	Presently it does not appear an accessibility study is needed for this property.	
Key Issues and Findings	The roof hatch has broken elements and requires repair.

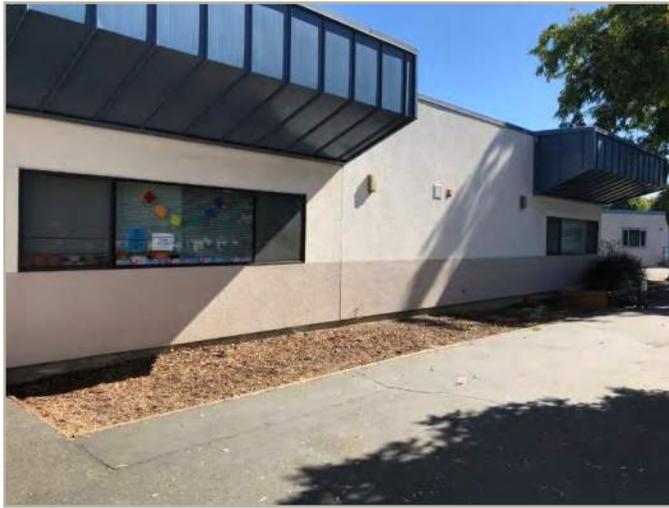
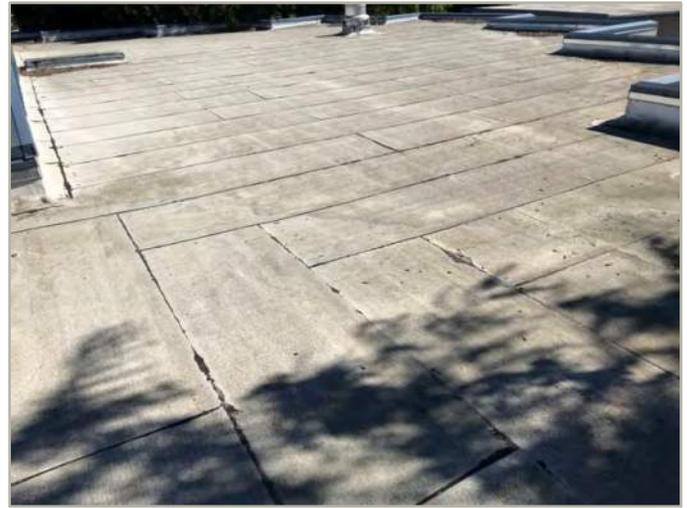
3. Classrooms

Classrooms: Systems Summary		
Electrical	Source and Distribution: Building panels with copper wiring. Fed from exterior service entrance section at transformer. Interior Lighting: T-12, LED, CFL	Good
Fire Alarm	Fire Alarm panel, smoke detectors, alarms, strobes, pull stations, back-up emergency lights, and exit signs	Good
Equipment/Special	None	Good
Accessibility	Presently it does not appear an accessibility study is needed for this property.	
Key Issues and Findings	Comprehensive replacement of building components as they reach the end of their useful service life.

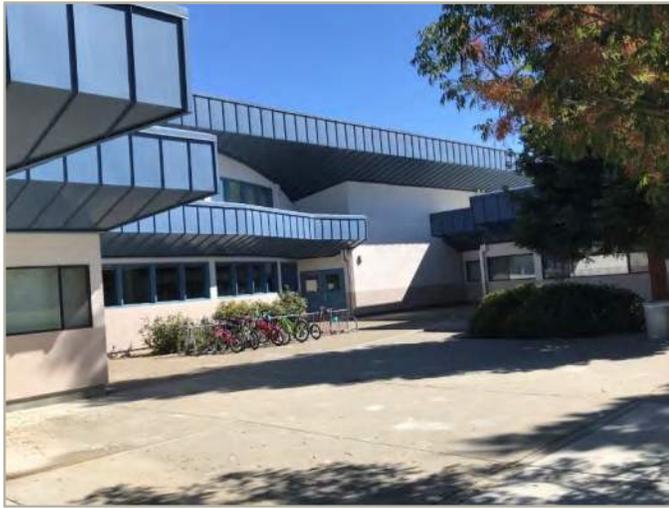
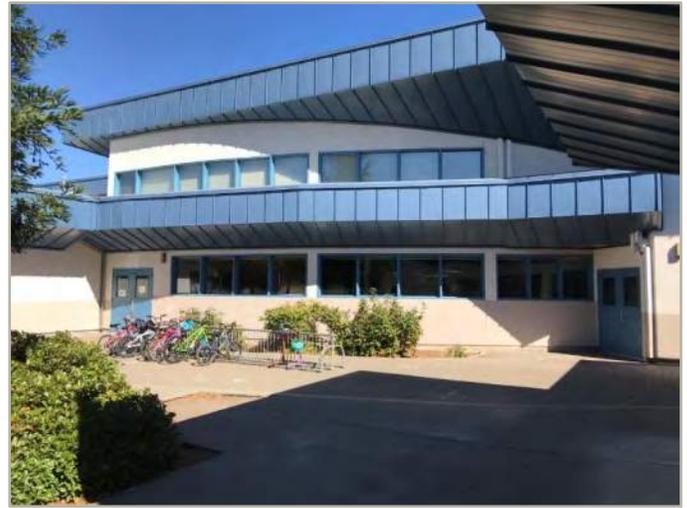
4. Guided Learning Center 920

Guided Learning Center: Systems Summary		
Electrical	Source and Distribution: Main service entrance section at transformer. Building panels with copper wiring. Fed from exterior service entrance section at transformer. Interior Lighting: T-12, LED, CFL	Good
Fire Alarm	Alarm panel, smoke detectors, alarms, strobes, pull stations, back-up emergency lights, and exit signs	Good
Equipment/Special	None	--
Accessibility	Presently it does not appear an accessibility study is needed for this property.	
Key Issues and Findings	No significant issues.

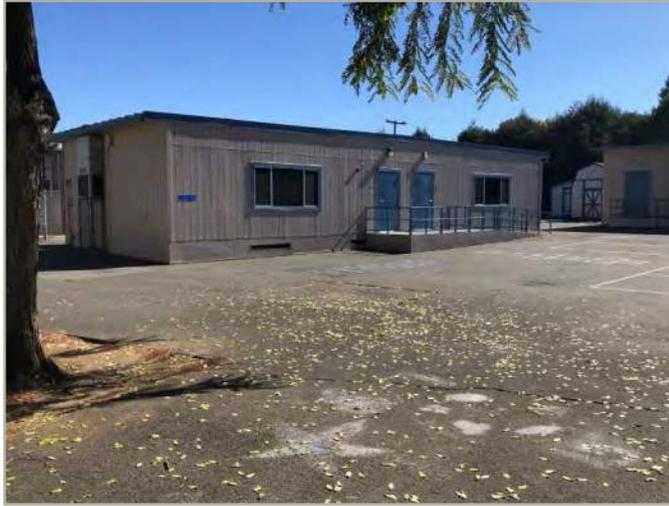
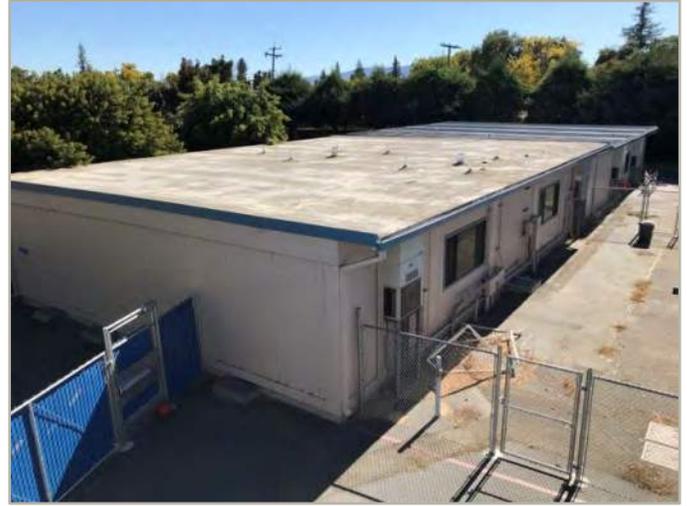
5. Modular Classrooms

Modular Classrooms: Systems Summary		
Electrical	Source and Distribution: Exterior building panels with copper wiring. Fed from exterior service entrance section at transformer. Interior Lighting: T-12, CFL	Good
Fire Alarm	Smoke detectors, alarms, strobes, pull stations, back-up emergency lights, and exit signs	Good
Equipment/Special	None	--
Accessibility	Presently it does not appear an accessibility study is needed for this property.	
Key Issues and Findings	No significant issues.

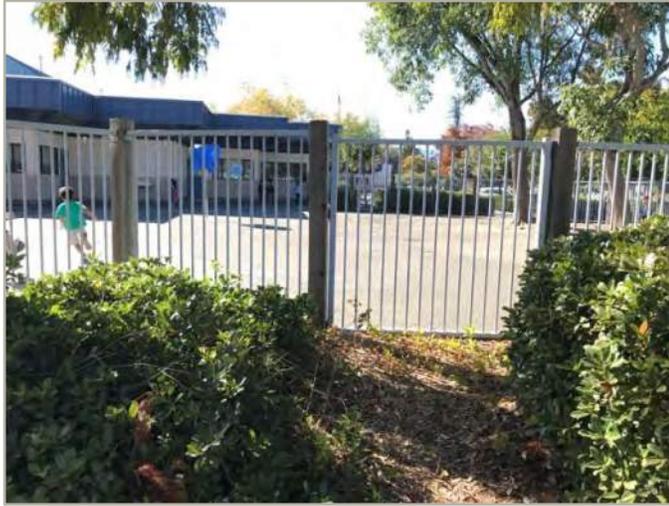
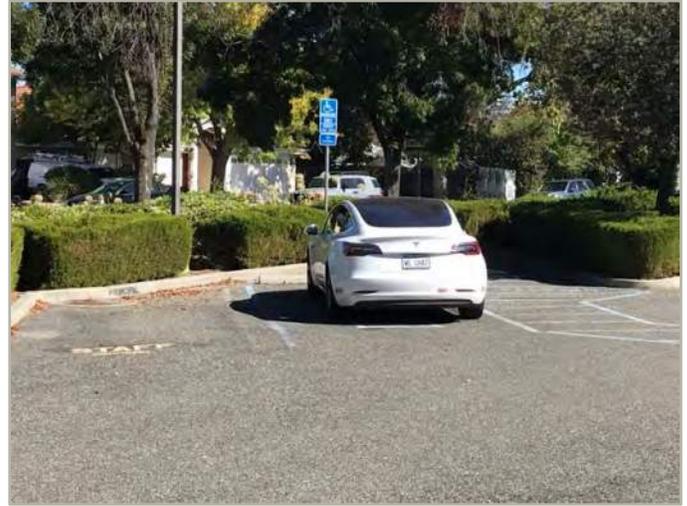
6. Site Summary

Accessibility	Presently it does not appear an accessibility study is needed for the exterior site areas.	
Key Issues and Findings	The play area asphalt surfaces are worn and cracked.
