# STEVENS CREEK ELEMENTARY SCHOOL

2020 | FACILITIES MASTER PLAN

# FACILITY CONDITION ASSESSMENT

STEVENS CREEK ELEMENTARY SCHOOL

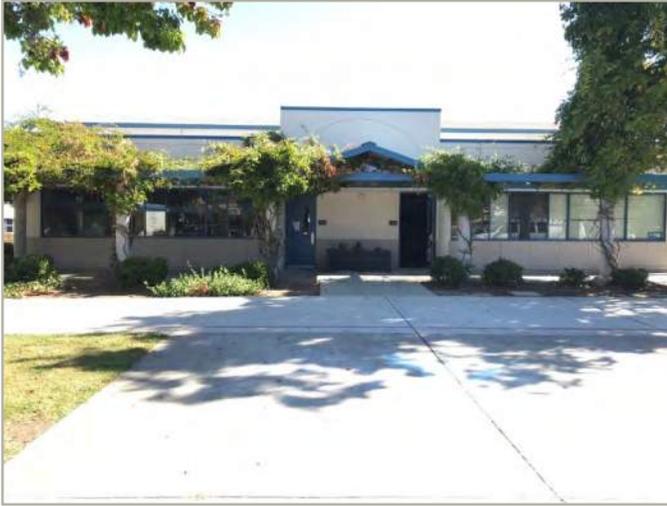
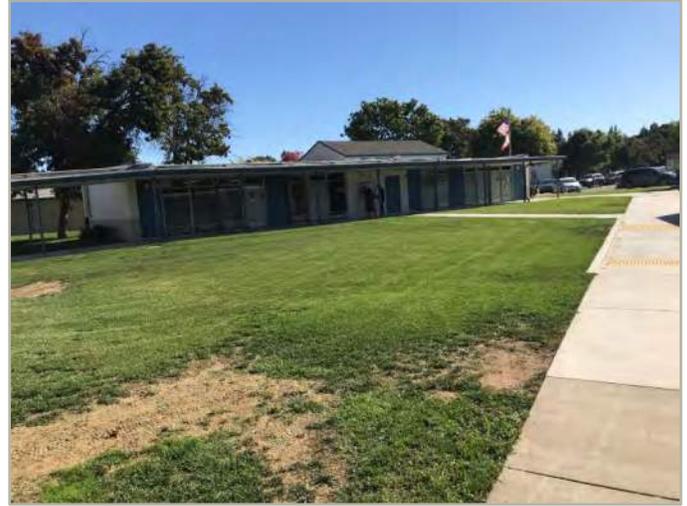
## 2. Administration Building 900

Administration: Systems Summary		
<b>Fire Alarm</b>	Fire Alarm panel, smoke detectors, alarms, strobes, pull stations, back-up emergency lights, and exit signs. Fire alarm systems were upgraded 2016	Good
<b>Equipment/Special</b>	None	--
<b>Accessibility</b>	Presently it does not appear an accessibility study is needed for this property.	
<b>Key Issues and Findings</b>	Roof replacement is recommended.

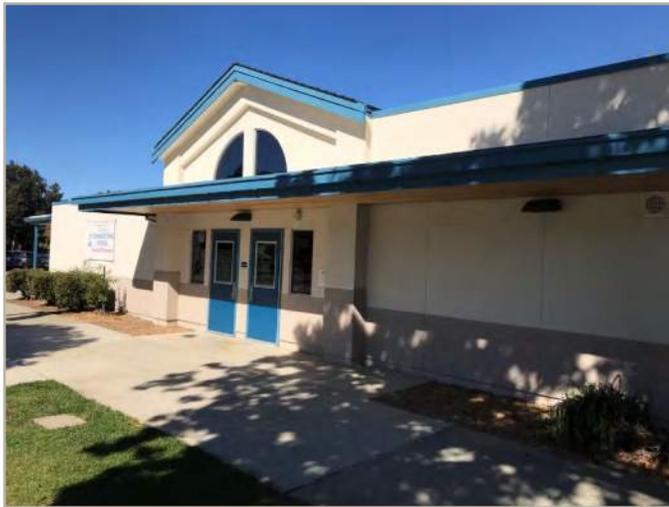
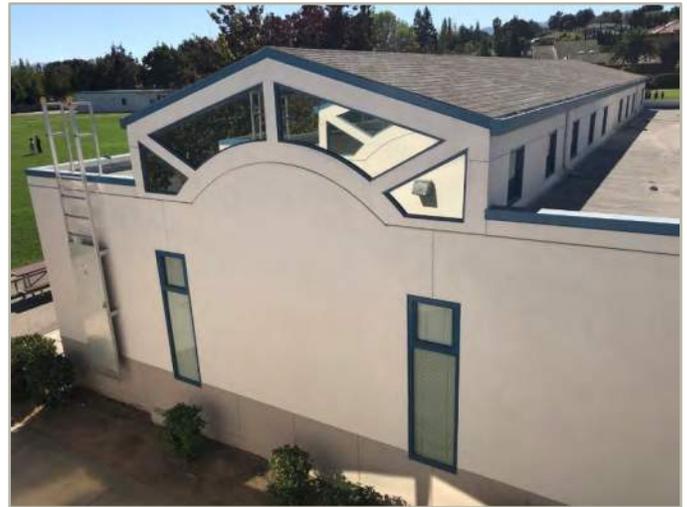
### 3. Classroom Buildings 1-18

<b>Classroom Buildings: Systems Summary</b>		
<b>Electrical</b>	Source & Distribution: Building panels with copper wiring. Fed from exterior service entrance section at transformer. Interior Lighting: T-12, LED, CFL	Good
<b>Fire Alarm</b>	Fire Alarm panel, smoke detectors, alarms, strobes, pull stations, back-up emergency lights, and exit signs. Fire alarm systems were upgraded 2016.	Good
<b>Equipment/Special</b>	None	--
<b>Accessibility</b>	Presently it does not appear an accessibility study is needed for this property.	
<b>Key Issues and Findings</b>	Roof is in poor condition HVAC equipment is in poor condition.

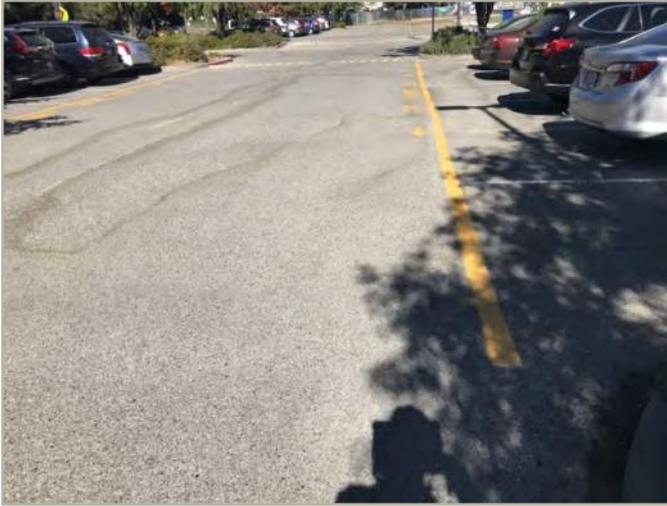
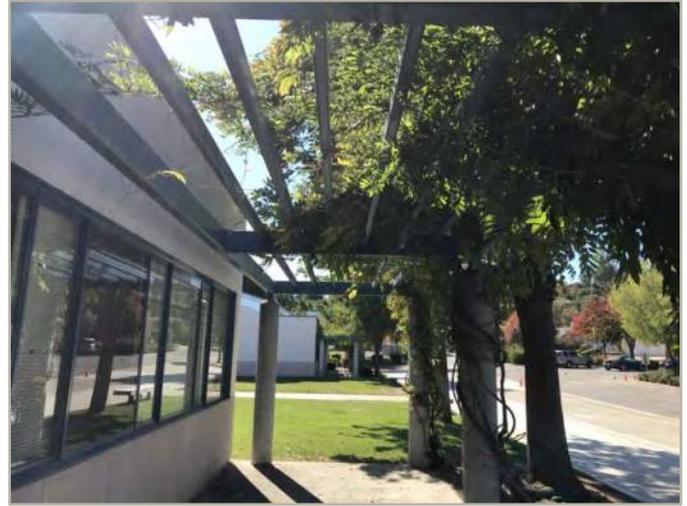
## 6. Site Summary

<b>Accessibility</b>	Presently it does not appear an accessibility study is needed for the exterior site areas. See Section 8.	
<b>Key Issues and Findings</b>	Asphalt play areas are in poor condition
