Rio Vista Elementary School

Property Executive Summary

Summary of Findings

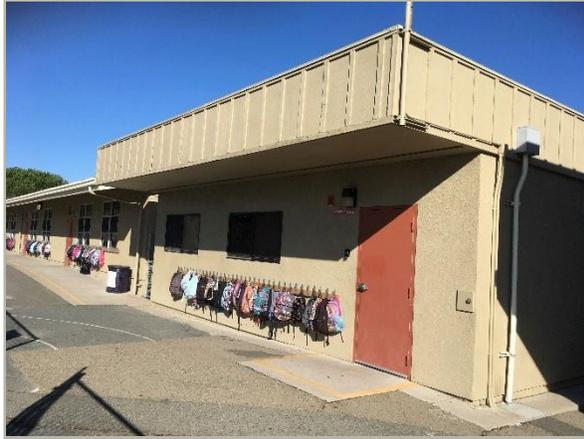
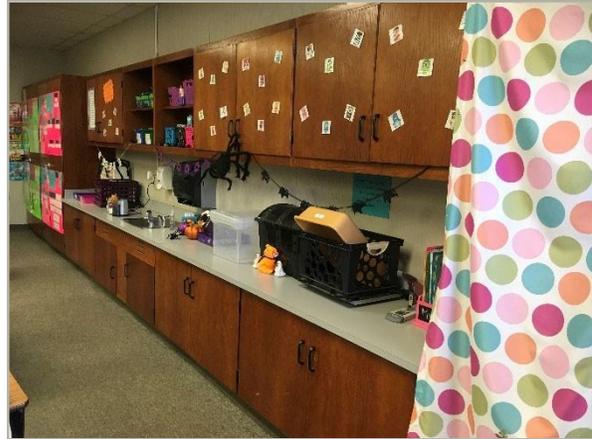
Building Type 3 Information		
Building Locations	Classroom Buildings C2-C6	
Constructed/ Renovated	2003	
Building Size	6,200 SF	
Number of Stories	1	
<i>System</i>	<i>Description</i>	<i>Condition</i>
Structure	Conventional wood-framed structure on concrete slabs Wood-framed bearing walls and wood-framed roofs	Good
Façade	Stucco with aluminum-framed operable windows	Fair
Roof	Primary: Flat construction with modified bituminous finish, metal	Fair
Interiors	Walls: Painted gypsum board & tack board Floors: Carpet, VCT Ceilings: ACT	Fair
Elevators	None	--
Plumbing	Copper supply, PVC waste and vent No hot water	Fair
HVAC	Packaged rooftop unit, split systems	Fair
Fire Suppression	Fire extinguishers, sprinkler system	Fair
Electrical	Source & Distribution: Exterior switchboard with copper wiring fed from exterior main distribution panel with copper wiring Interior Lighting: T-8	Fair
Fire Alarm	Alarm panel, smoke detectors, alarms, strobes, pull stations, back-up emergency lights, and exit signs	Fair

Equipment/Special	None	--
Key Issues & Findings	None
