Pleasant Hill Middle School (includes Pleasant Hill Education Center)

Property Executive Summary

Summary of Findings

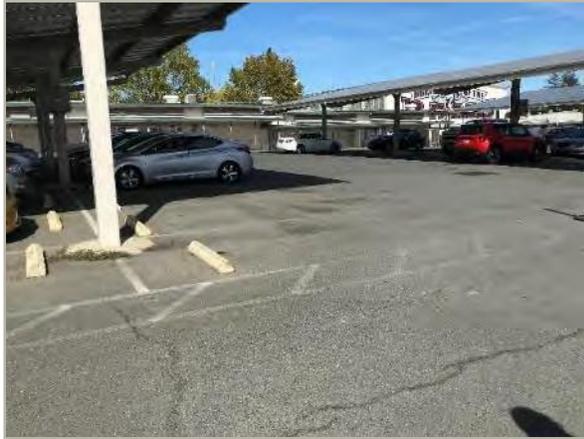
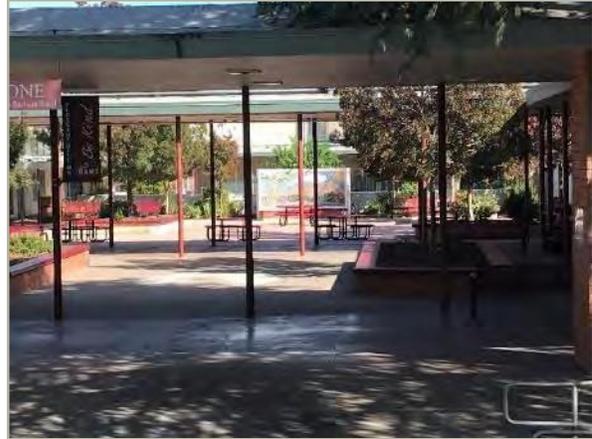
Site Summary Information

Site Information		
Lot Size	28.95 acres (estimated)	
Parking Spaces	253 total spaces all in open lots; 21 of which are accessible 17 accessible (included in total above), 4 van-accessible	
<i>System</i>	<i>Description</i>	<i>Condition</i>
Pavement/Flatwork	Asphalt lots with areas of concrete and concrete sidewalks, curbs, ramps, and stairs	Fair
Site Development	Property entrance signage, chain link fencing, chain link dumpster enclosures Sports courts, fencing, and site lights	Fair
Landscaping & Topography	Moderate landscaping features Irrigation present No retaining walls Low to moderate site slopes throughout	Fair
Draining Systems and Erosion Control	Surface flow, inlets, swales, underground piping	Fair
Utilities	Municipal water and sewer Local utility-provided electric and natural gas	Fair
Site Lighting	Pole-mounted: metal halide Building-mounted: metal halide	Fair
Ancillary Structures	Steel-framed carports for solar system.	Good

Key Issues & Findings	None
