Sequoia Middle School
 EXISTING SITE INFORMATION

Sequoia Middle School

Sequoia Middle School OVERVIEW

Property Executive Summary

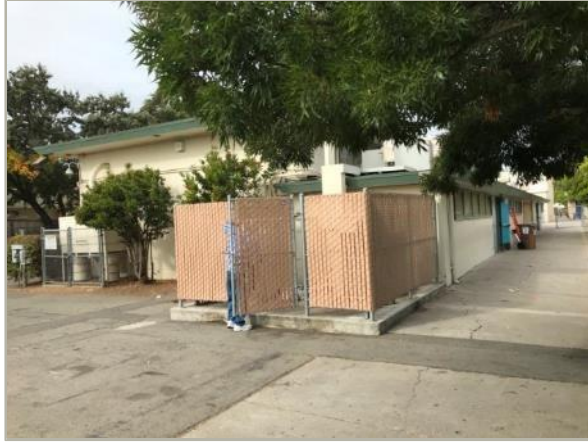
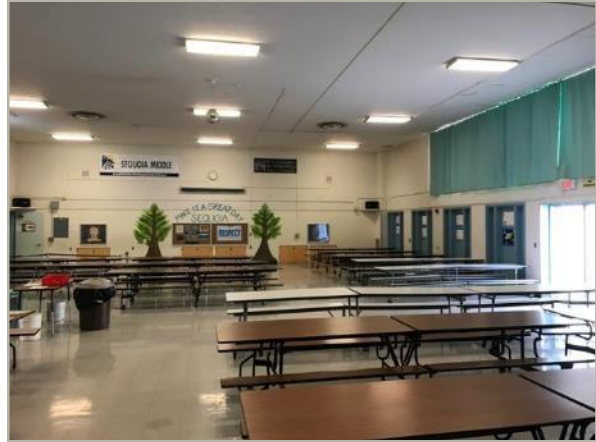
Building Multipurpose, Shop Information		
Building Locations	Multipurpose, shop	
Constructed/ Renovated	1951	
Total Area	12,400 SF	
Number of Stories	1	
<i>System</i>	<i>Description</i>	<i>Condition</i>
Structure	Conventional wood-framed structure on concrete slab and wood-framed roofs	Fair
Façade	Stucco with steel windows	Fair
Roof	Primary: Flat construction with modified bituminous finish	Fair
Interiors	Walls: Painted gypsum board Floors: VCT, ceramic tile, quarry tile Ceilings: Painted gypsum board, ACT	Fair
Elevators	None	--
Plumbing	Copper supply, cast iron waste and vent Gas water heater	Fair
HVAC	Individual package, heat pump, split-system units Supplemental components: None	Good
Fire Suppression	Hydrants, fire extinguishers	Fair
Electrical	Source & Distribution: Main switchboard with copper wiring Interior Lighting: T-12, CFL, halogen Emergency: None	Fair
Fire Alarm	Alarm panel, smoke detectors, alarms, strobes, pull stations, back-up emergency lights, and exit signs	Fair

Equipment/Special	Commercial kitchen equipment	Fair
Key Issues & Findings	None noted.

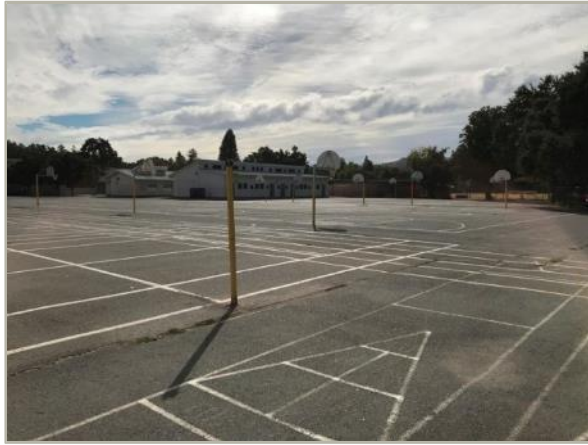
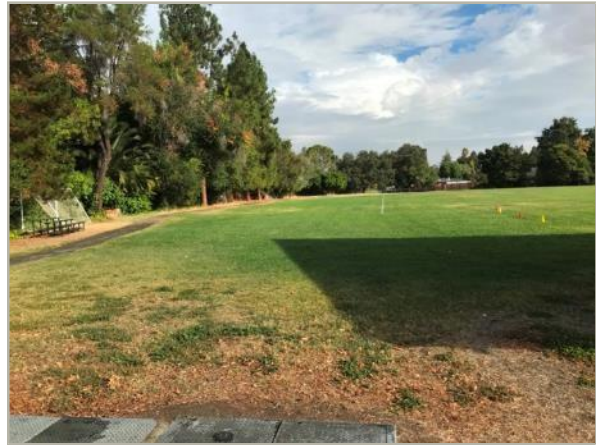
Site Summary Information

Site Information		
Lot Size	15.14 acres (estimated)	
Parking Spaces	48 total spaces all in open lots; three of which are accessible Three accessible (included in total above), none van-accessible	
<i>System</i>	<i>Description</i>	<i>Condition</i>
Pavement/Flatwork	Asphalt lots with areas of concrete and concrete sidewalks, curbs, ramps, and stairs	Fair
Site Development	Property entrance signage, chain link fencing, CMU dumpster enclosures Playgrounds and sports courts Limited park benches, picnic tables, trash receptacles	Fair
Landscaping & Topography	Moderate landscaping features Irrigation present No retaining walls Low to moderate site slopes throughout	Fair
Draining Systems and Erosion Control	Surface flow, inlets, underground piping, municipal system	Fair
Utilities	Municipal water and sewer Local utility-provided electric and natural gas	Fair
Site Lighting	Pole-mounted: metal halide Building-mounted: LED	Fair

Ancillary Structures	Storage trailers	Fair
Key Issues & Findings	None noted
