Clayton Valley High School

Property Executive Summary

Clayton Valley High School Summary of Findings

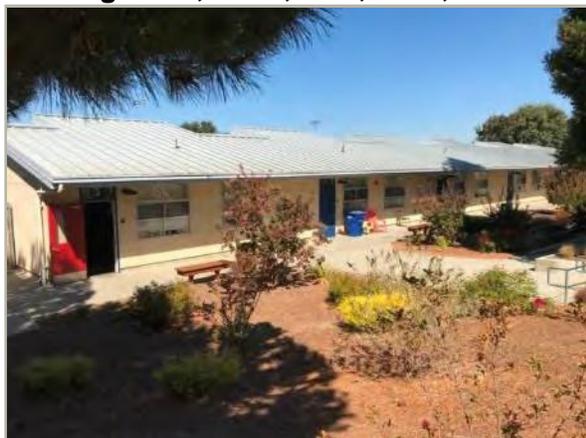
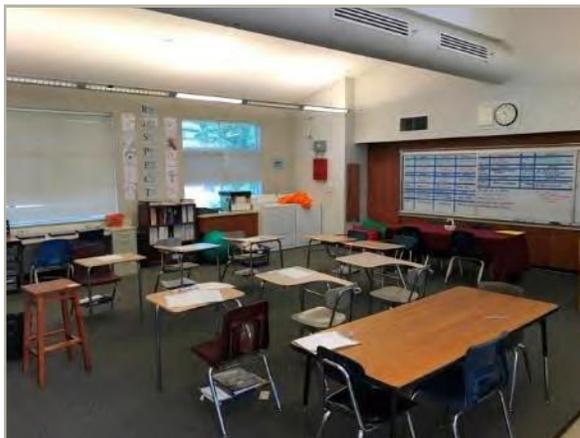
Building H 1-3, H 4-9, I 1-2, J 1-4, L 100-200 Information		
Building Locations	Classroom Buildings	
Constructed/ Renovated	2000s	
Total Area	19,400 SF	
Number of Stories	1	
<i>System</i>	<i>Description</i>	<i>Condition</i>
Structure	Conventional wood-framed structure on concrete slabs with wood-framed roofs	--
Façade	Stucco with aluminum windows	--
Roof	Gable construction with asphalt shingles	--
Interiors	Walls: Painted gypsum board, vinyl Floors: Carpet, VCT, Unfinished Ceilings: Painted gypsum board, ACT	--
Elevators	None	--
Plumbing	Copper supply, cast iron waste and vent No hot water	Fair
HVAC	Individual heat pump, split-system units Supplemental components: ductless split-systems	Fair
Fire Suppression	Wet-pipe sprinkler system (L building only); hydrants, fire extinguishers,	Fair
Electrical	Source & Distribution: Main panel with copper wiring Interior Lighting: T-8, CFL Emergency: None	Fair
Fire Alarm	Alarm panel, smoke detectors, alarms, strobes, pull stations, and exit signs	Fair

Equipment/Special	None	--
Key Issues & Findings	None noted
