Olympic Continuation High School
 EXISTING SITE INFORMATION

Property Executive Summary

Property Condition

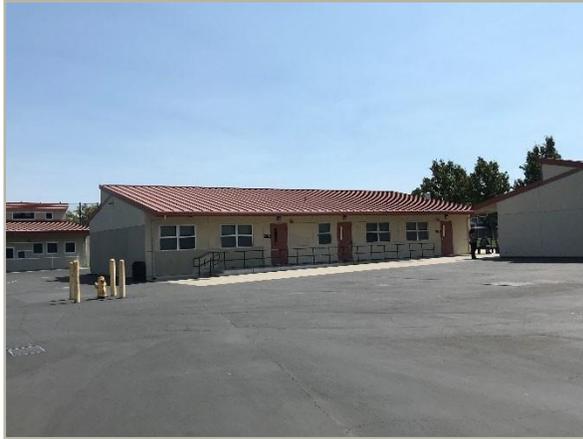
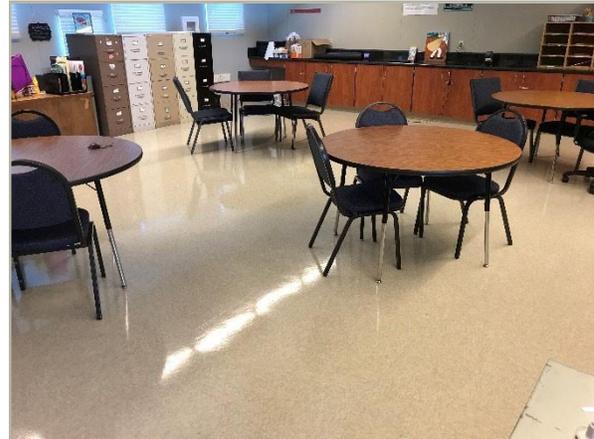
Building Type 2 Information

Fire Alarm	Alarm panel, smoke detectors, alarms, strobes, pull stations	Fair
Equipment/Special	None	--
Key Issues & Findings	None
