SITE FUNCTIONALITY ASSESSMENT HEARST ELEMENTARY SCHOOL

Site Functionality Assessment

HEARST ELEMENTARY SCHOOL

FACILITY CONDITION ASSESSMENT

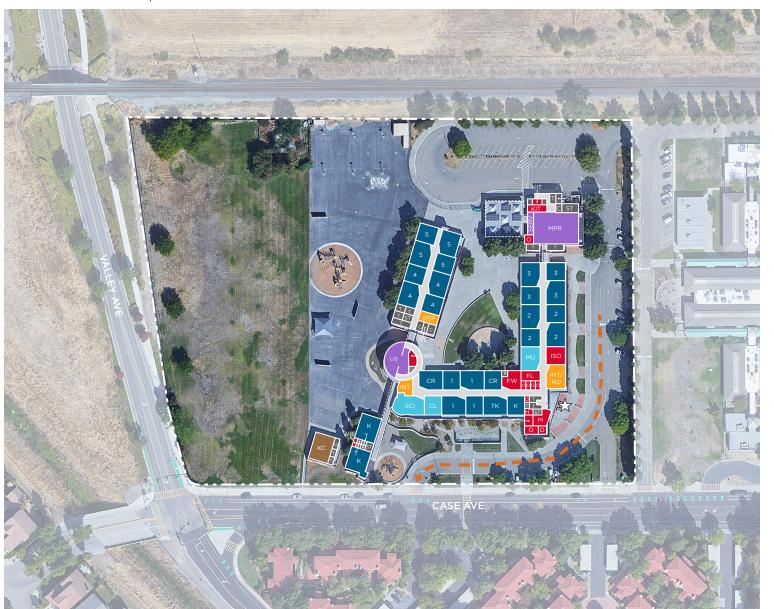
Existing Site Plan | HEARST ELEMENTARY SCHOOL

Electives / Labs
CL Computer Lab
MU Music Room SCI Science Lab

Shared Spaces
MPR Multi-Purpose Room LIB Library SERV Serving Area (Food Service)

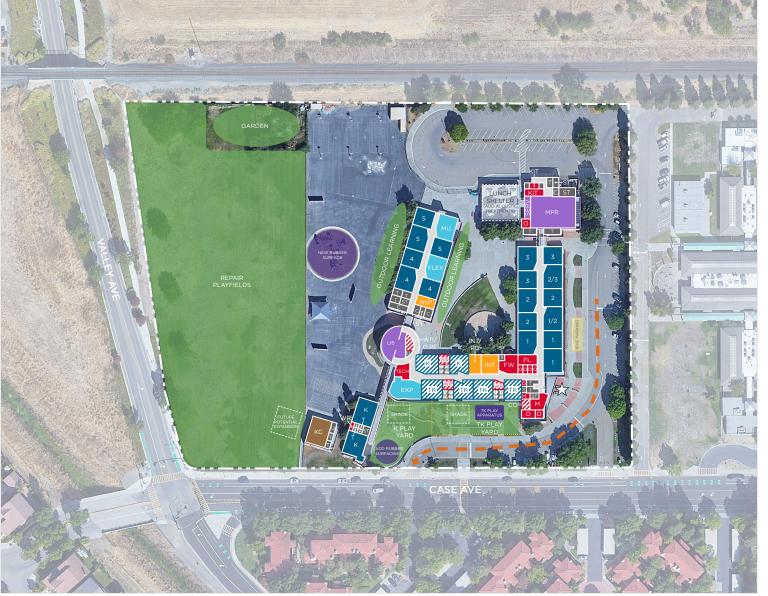
Proposed Master Plan Diagram | HEARST ELEMENTARY SCHOOL

Teaching Stations:	
PS (Preschool)	0
TK (Transitional Kinder)	4
Kindergarten	4
Grades 1-3	11
Grades 4-5	6
SDC mild/mod	0
SDC mod/sev	1
Sub-Total:	26
Additional Spaces:	
Exploration Lab / Music / Art	3
After School Care	1

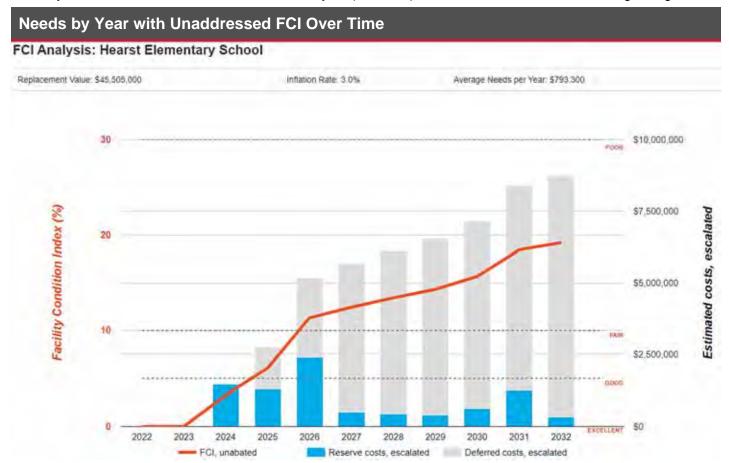
Campus Level FCI:

The vertical bars below represent the year-by-year needs identified for the entire campus. The orange line in the graph below forecasts what would happen to the campus FCI (left Y axis) over time, assuming zero capital expenditures over the next ten years. The dollar amounts allocated for each year (blue bars) are associated with the values along the right Y axis.

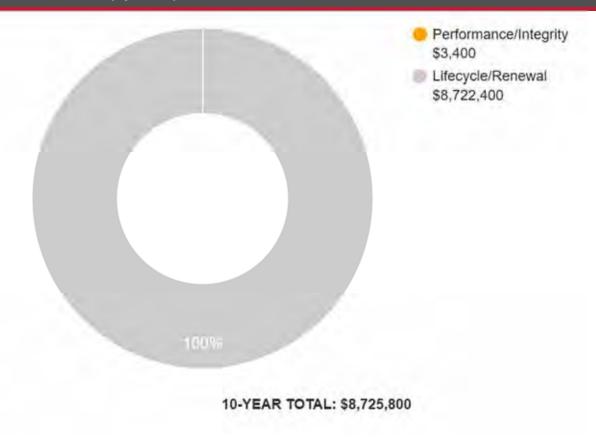
Plan Type Distribution (by Cost)

Plan Type Descriptions					
Safety	An observed or reported unsafe condition that if left unaddressed could result in injury; a system or component that presents potential liability risk.				
Performance/Integrity	Component or system has failed, is almost failing, performs unreliably, does not perform as intended, and/or poses risk to overall system stability.				
Accessibility	Does not meet ADA, UFAS, and/or other handicap accessibility requirements.				
Environmental	Improvements to air or water quality, including removal of hazardous materials from the building or site.				
Retrofit/Adaptation	Components, systems, or spaces recommended for upgrades in in order to meet current standards, facility usage, or client/occupant needs.				
Lifecycle/Renewal	Any component or system that is not currently deficient or problematic but for which future replacement or repair is anticipated and budgeted.
