Site Functionality Assessment

STEAM PRESCHOOL

FACILITY CONDITION ASSESSMENT

Steam Preschool 4667 Bernal Avenue Pleasanton, California 94566

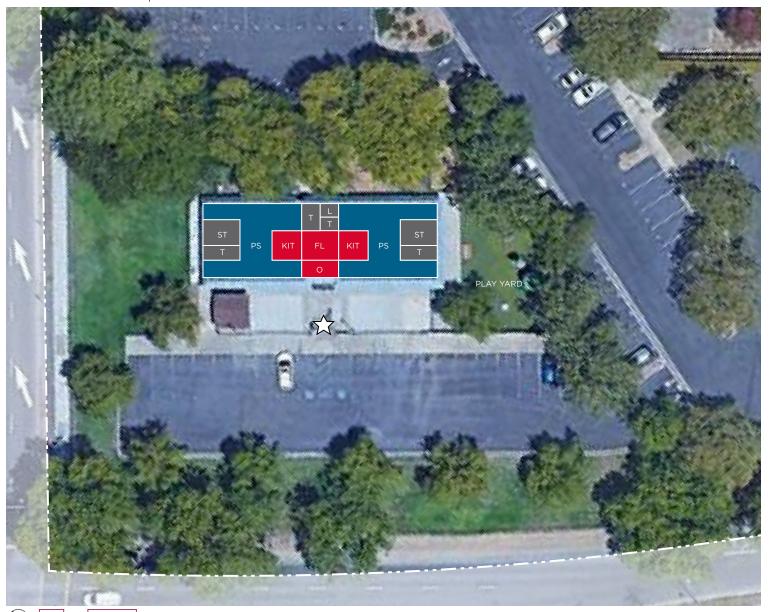
Existing Site Plan STEAM PRESCHOOL

Classrooms PS Preschoool

Admin / Faculty KIT Kitchen

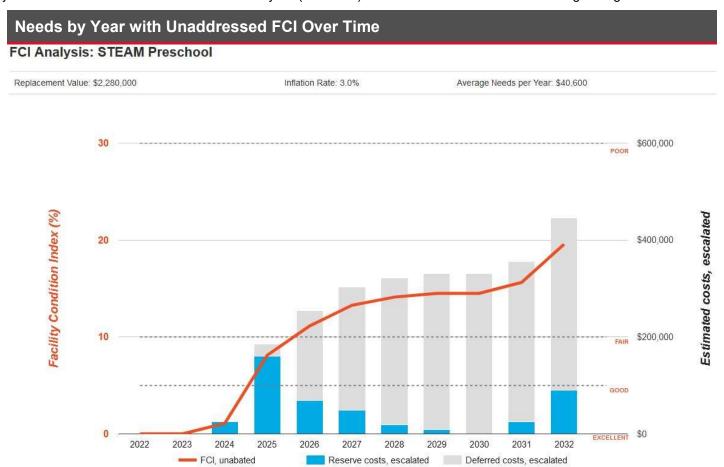
The vertical bars below represent the year-by-year needs identified for the site. The orange line in the graph below forecasts what would happen to the FCI (left Y axis) over time, assuming zero capital expenditures over the next ten years. The dollar amounts allocated for each year (blue bars) are associated with the values along the right Y axis.

FCI Analysis STEAM Presch	1001(2003)		
Replacement Value \$ 2,280,000	Total SF 3,000	Cost/SF \$ 760	
	Est Re	serve Cost	FCI
Current		\$ 0	0.0 %
3-Year		\$ 185,100	8.1 %
5-Year		\$ 302,700	13.3 %
10-Year		\$ 446,000	19.6 %

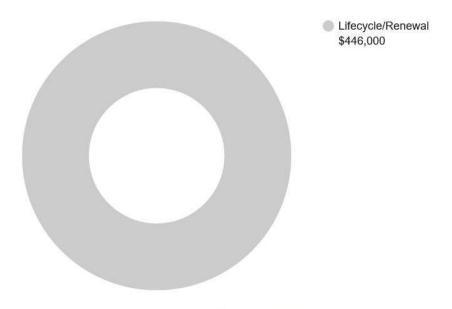
Plan Type Distribution (by Cost)

10-YEAR TOTAL: \$446,000

Plan Type Descriptions			
Safety	An observed or reported unsafe condition that if left unaddressed could reinjury; a system or component that presents potential liability risk.	esult in	
Performance/Integrity	Component or system has failed, is almost failing, performs unreliably, do perform as intended, and/or poses risk to overall system stability.	es not	
Accessibility	Does not meet ADA, UFAS, and/or other accessibility requirements.		
Environmental	Improvements to air or water quality, including removal of hazardous mate from the building or site.	erials	
Retrofit/Adaptation	Components, systems, or spaces recommended for upgrades in in order current standards, facility usage, or client/occupant needs.	to meet	
Lifecycle/Renewal	Any component or system that is not currently deficient or problemati which future replacement or repair is anticipated and budgeted.	c but for
